HAZARDOUS AND REGULATED MATERIALS PRE-DEMOLITION ASSESSMENT REPORT

SLOCAN CURLING CLUB BUILDING

903 Hume Street
Slocan, BC

Report Date: August 9, 2022

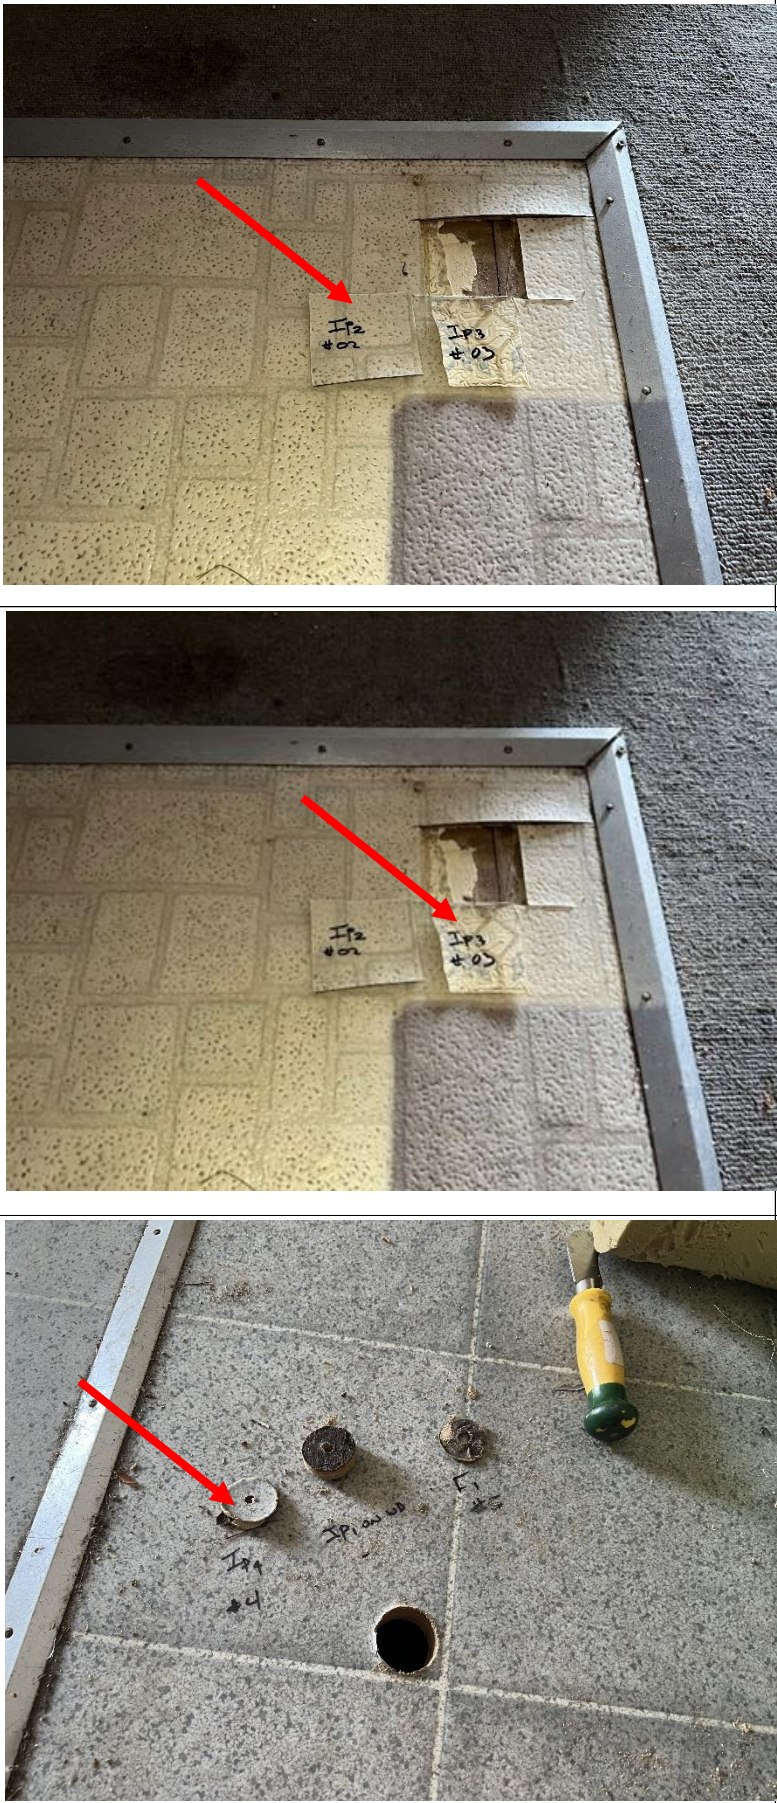
Ip 2 Beige tile pattern VSF	5808-02	No Asbestos Detected
	Ip 3 Cream and beige diamond tile pattern VSF	5808-03	No Asbestos Detected
	Ip 4 Green tile pattern VSF	5808-06	No Asbestos Detected

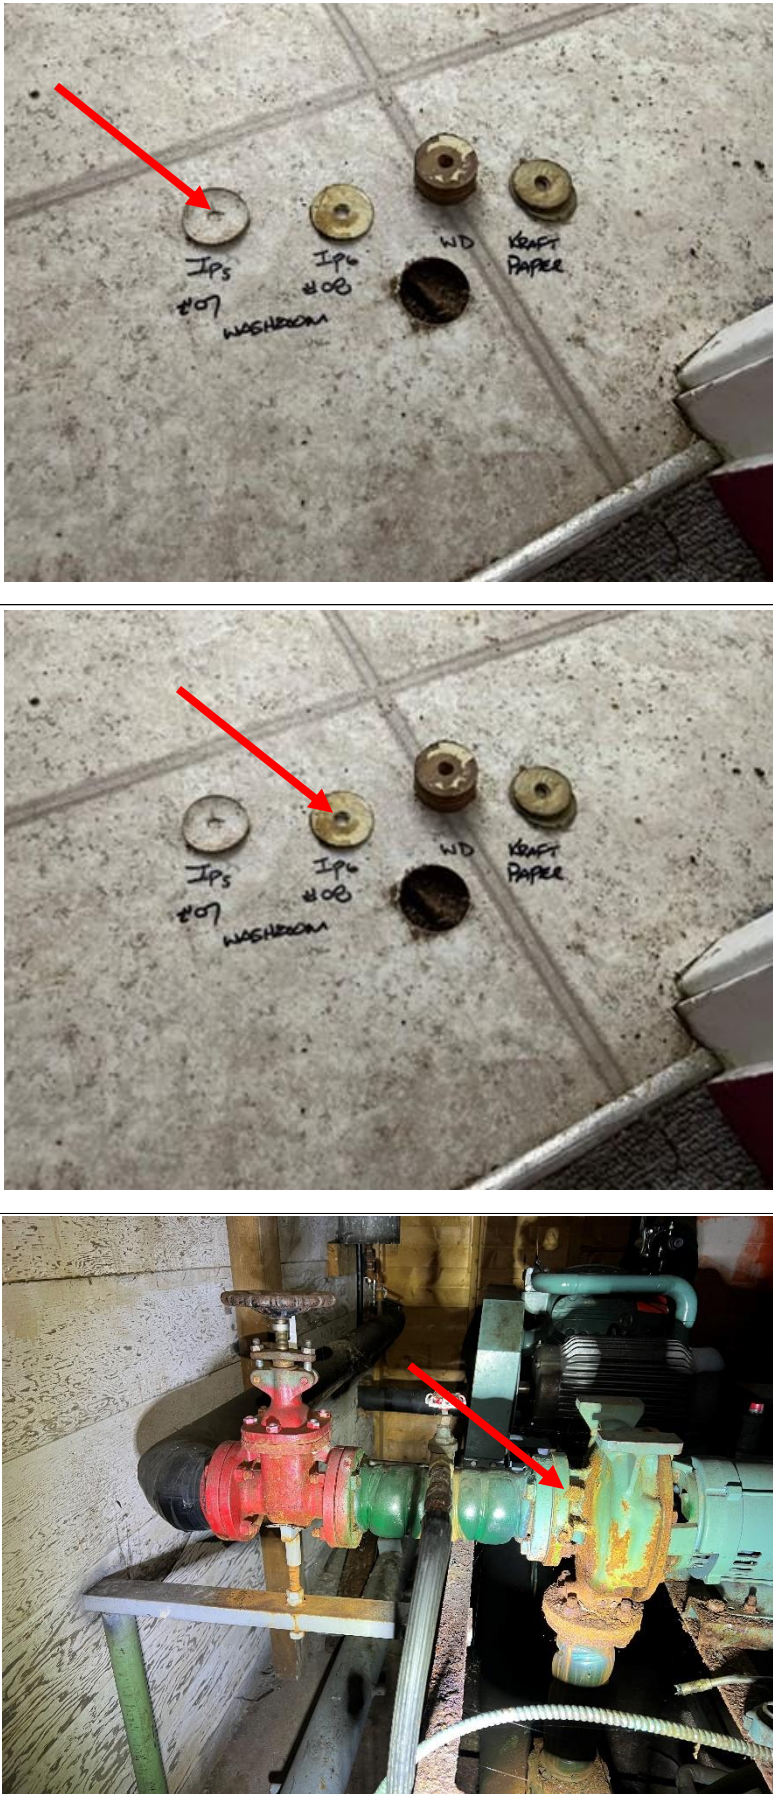
Ip 5 Cream 13"x13" tile pattern Vest	5808-07	No Asbestos Detected
	Ip 6 Beige VSF	5808-08	No Asbestos Detected
	Kp 1 Pipe flange gaskets	5808-09	70% Chrysotile Asbestos

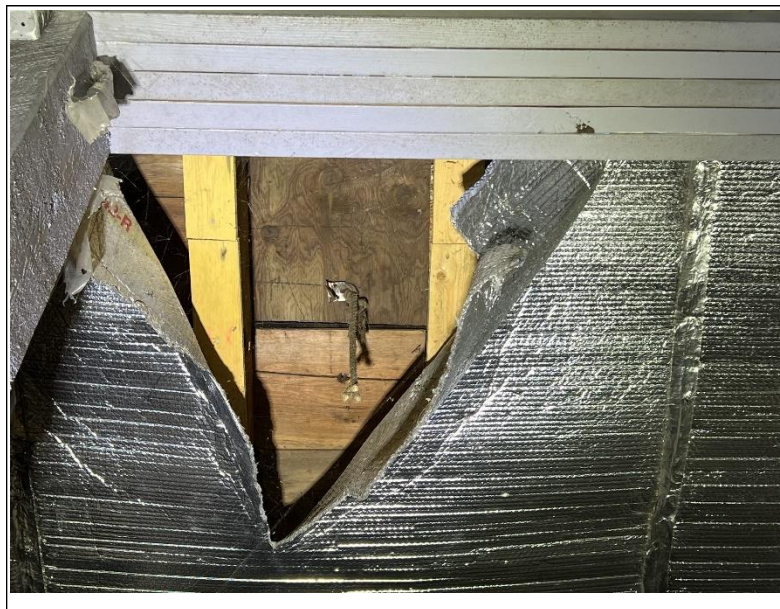
Code Modifier	Material Description	Sample Number / Information	Lab Results
Qs 1	Asphalt shingle	5808-10	No Asbestos Detected
Qs 2	Roofing underlay	5808-11	No Asbestos Detected
T 1	Kraft paper backed fiberglass building thermal insulation	Not Sampled	Known Non- Asbestos Application

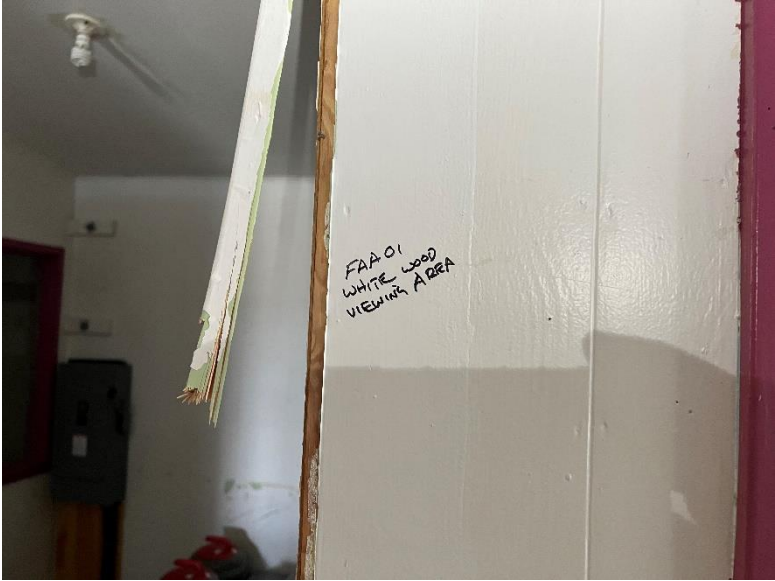
White on interior wood	FAA-01	700 ppm

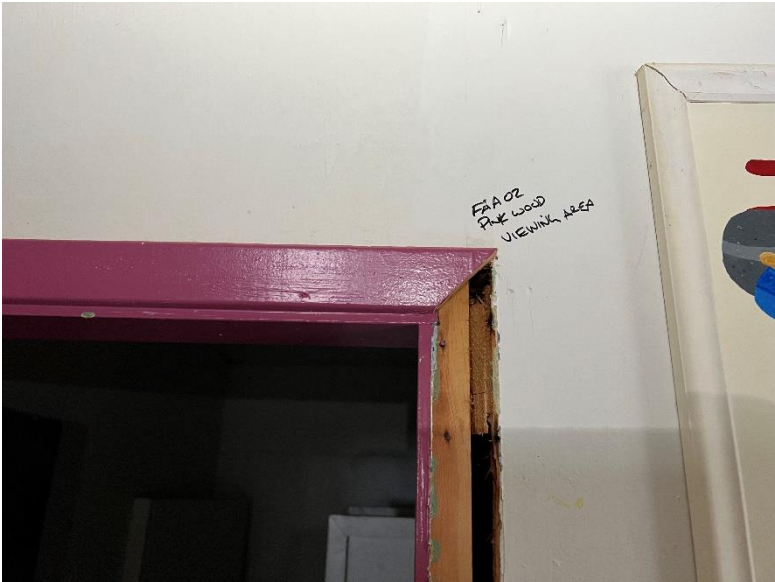
Pink on interior wood	FAA-02	760 ppm

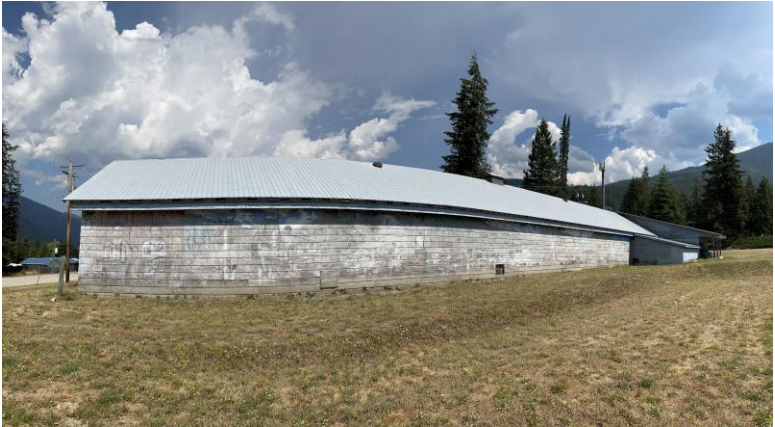
Grey on white on exterior wood	FAA-03	230 ppm

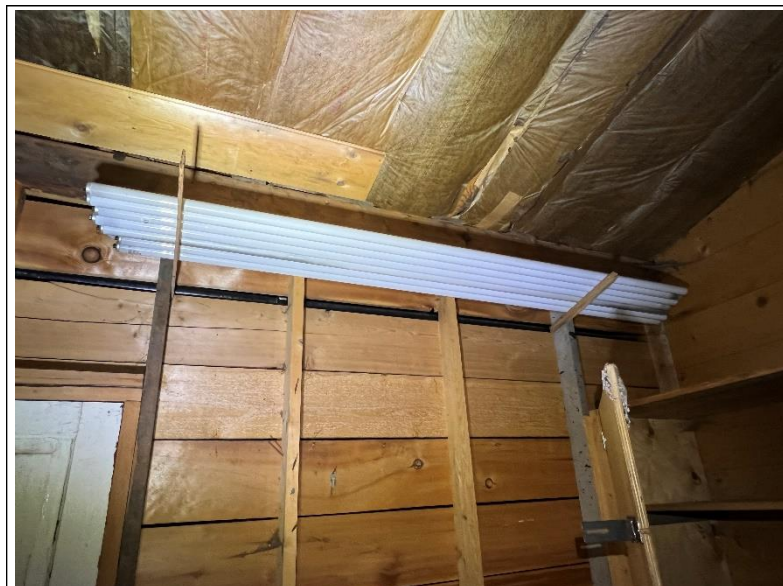
Material Description	Sample Number / Information	Lead Conc.
Mercury containing light tubes

- Where removal is required to facilitate renovation or demolition activities, collect mercury vapour lighting (high voltage lights and fluorescent light tubes) for vapour recycling at www.lighrecycle.ca/collection-site-locator and wall mounted thermostat activation switches should be collected and returned for inclusion in the [HRAI Thermostat Recovery Program](#). Use caution to not break the glass thereby releasing mercury.
