Village of Slocan Public Works Waterfront Breakwater Steel Pontoon Inspection Report

Name: Lachlan McGreal, Public Works Acting Supervisor
Organization: Village of Slocan
Phone: (250) 355 2500
From: Vern Johnston
Email: operations@divingdynamics.com
Date: Date of Inspection August 9th, 2022
Scope: Inspection Services – Slocan Waterfront Breakwater Inspection
Report Number: 08.09.2022.VOS – Rev 1.1

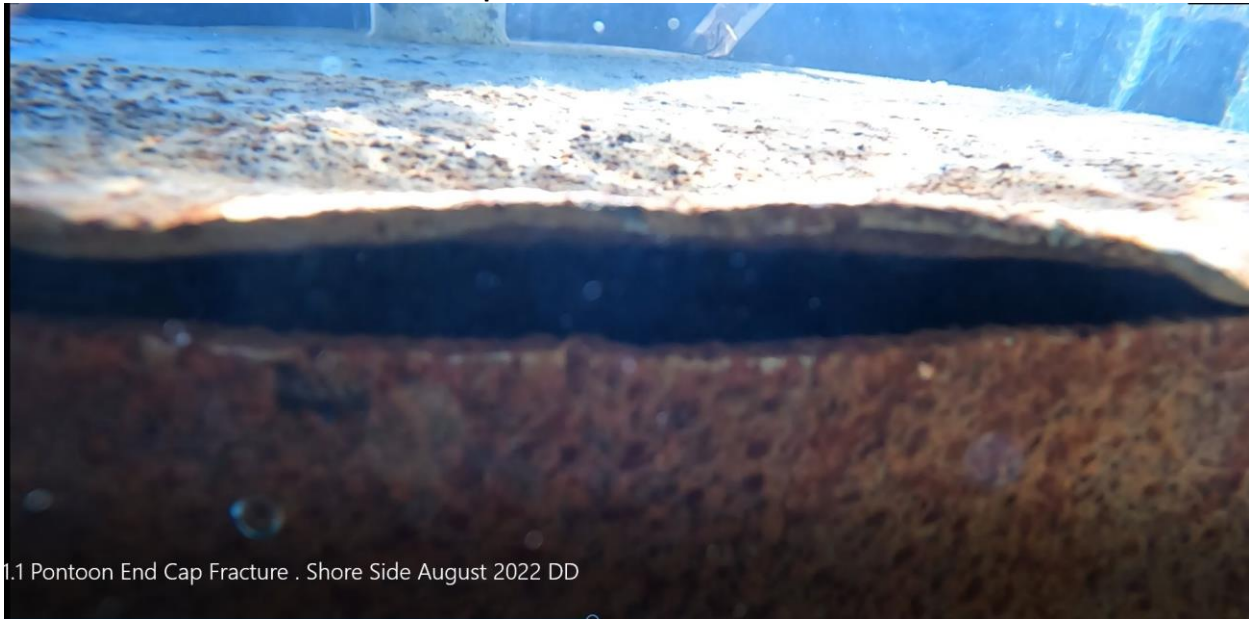
Photo 1.1

The shoreside pontoon is compromised at the end cap weld on the pipes invert. The failed weld is open approximately 30% on either side of the invert rising towards the mid-height of the vertical wall. The maximum opening at the invert is approximately 10mm, narrowing off to about 2mm on the vertical wall. It is apparent that the weld failed due to the pontoon load bearing weight encountering the rock substrate over extended time.

End Cap Invert – Failed Weld – 10mm

1.1 Pontoon End Cap Fracture . Shore Side August 2022 DD

- . Pick the shoreside pontoons with a spreader bar – load distribution recommended
- . Place the pontoons on support cribbing at an elevation to facilitate the pontoon repair
- . Repair the end cap as per industry standard procedures
- . Pressure test pontoon

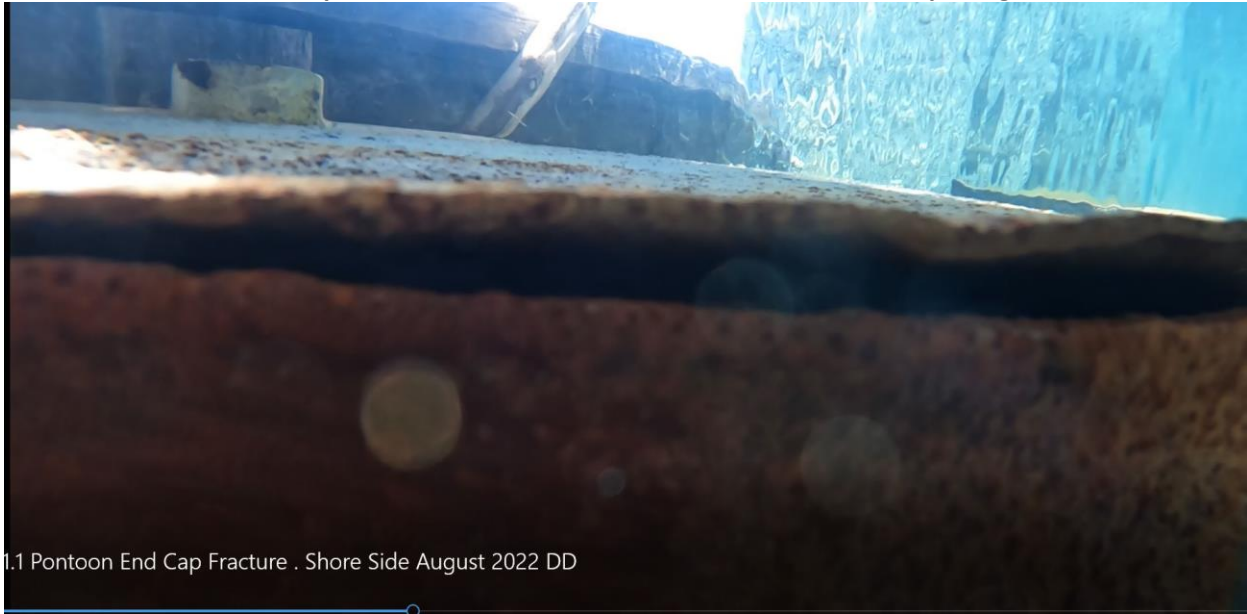
Photo 1.2

End Cap Vertical Wall Left – Failed Weld – 2mm - 5mm Opening

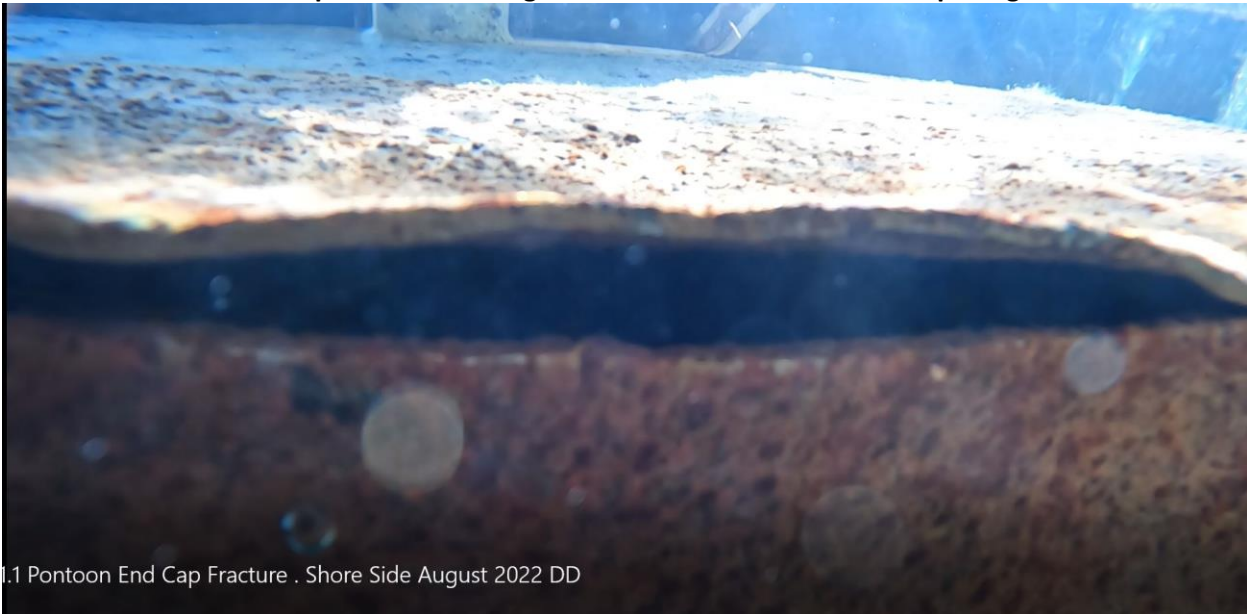
Photo 1.3

End Cap Vertical Wall Right – Failed Weld – 2mm - 5mm Opening

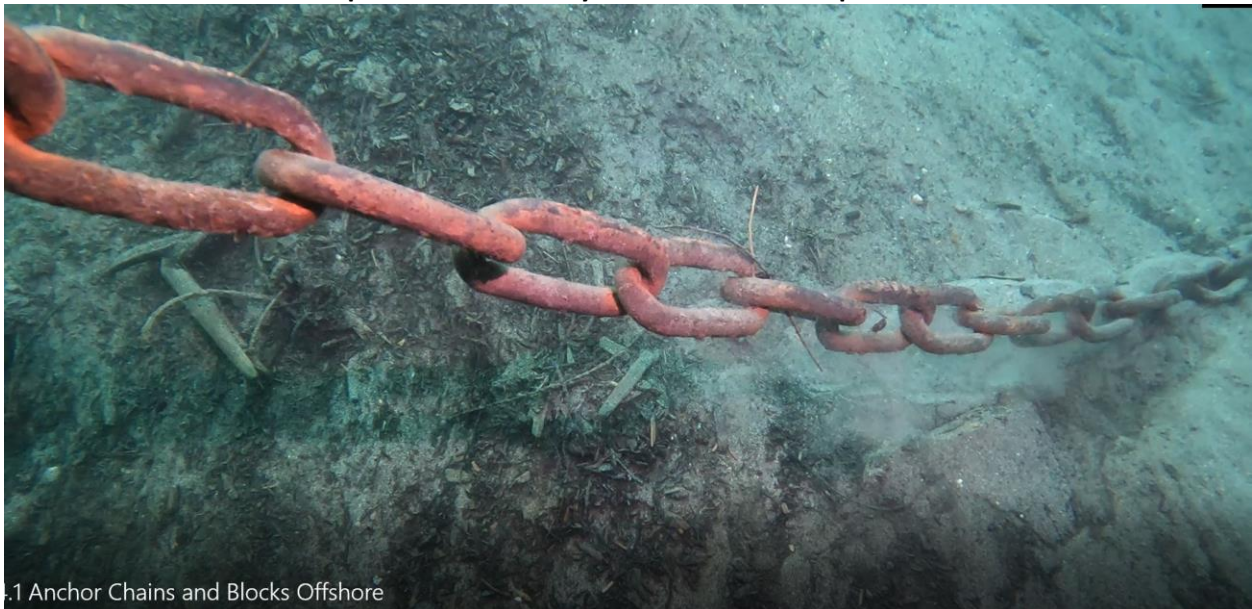
Photo 1.4

The anchor chains were inspected visually with no signs of compromise.

- . ½" Long Link Chain
- . Inspection at areas of high dynamic movement showed no signs of hardware wear
- . Significant chain 'scope' was on bottom
- . No signs of chain movement on the substrate from wind events

Deep Anchor Chain – Dynamic Location – Depth 67ffw

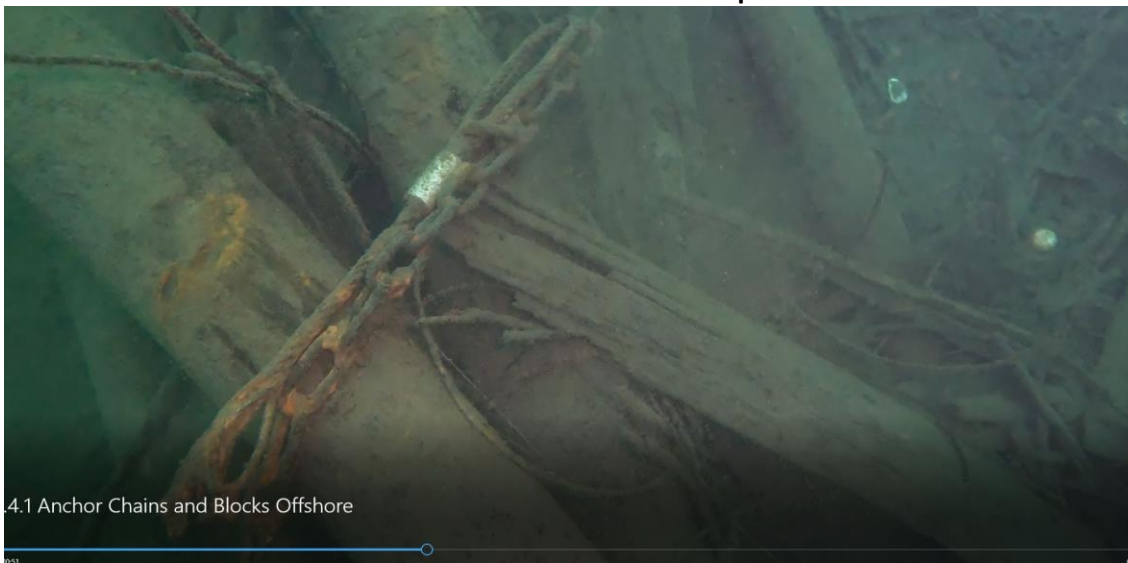
Photo 1.5

Ballast Block Inspections – Visually inspected with no signs of compromise

- . Full Size Loc-blocks - Sleeved PVC for wire rope pass
- . Chain to Cable connections were tight *Shackle
- . No visual signs of compromise on the wire ropes
- . No signs of ballast block movement due to wind events

Anchor Chain to Loc-Block Cable – Depth 67ffw

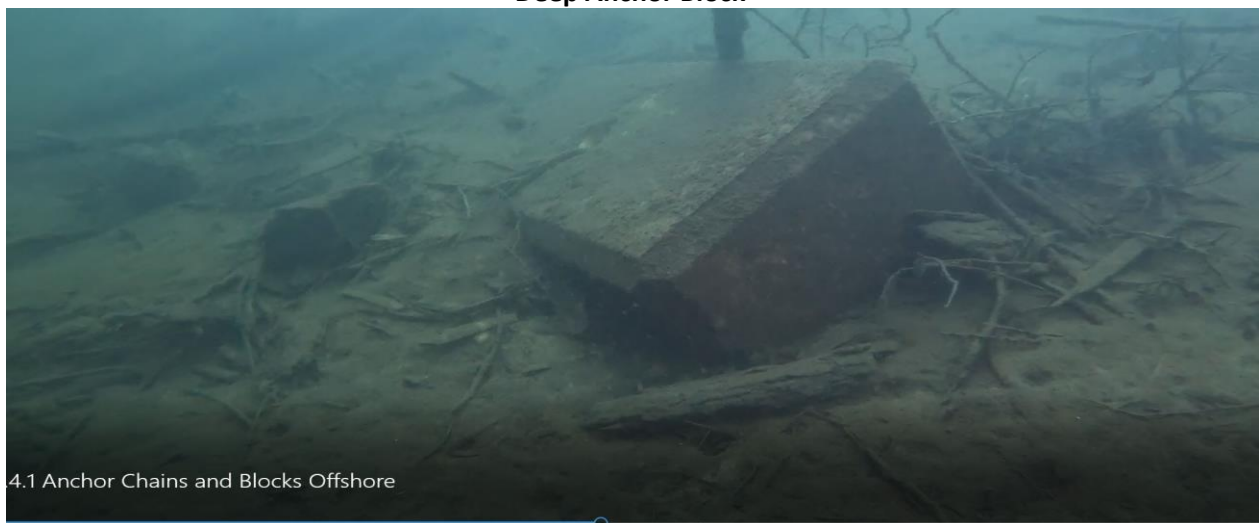
Photo 1.6

Deep Anchor Block

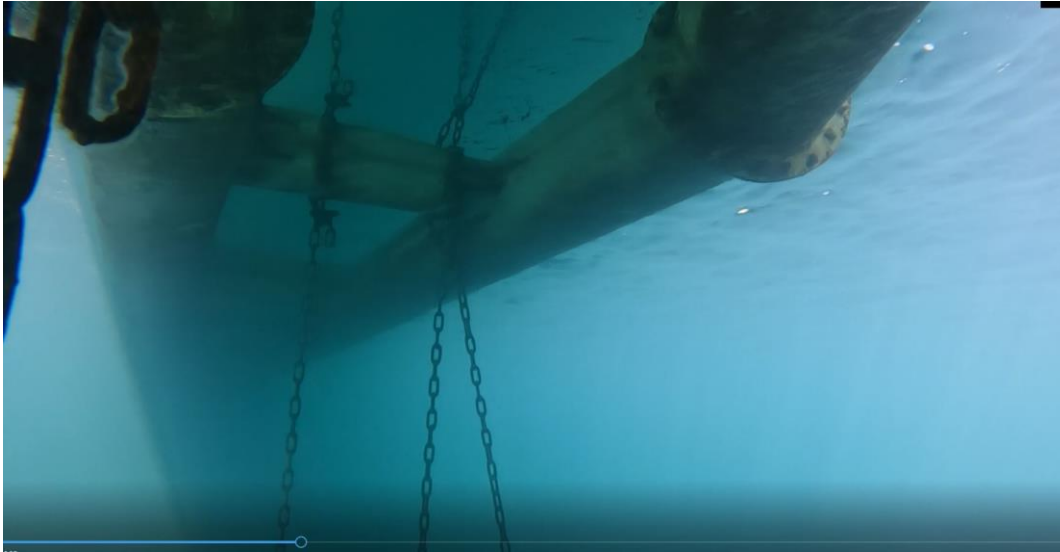
Photo 1.7

- . All hardware was tight with no signs of compromise

Anchor Chain to Pontoon Attachment - General

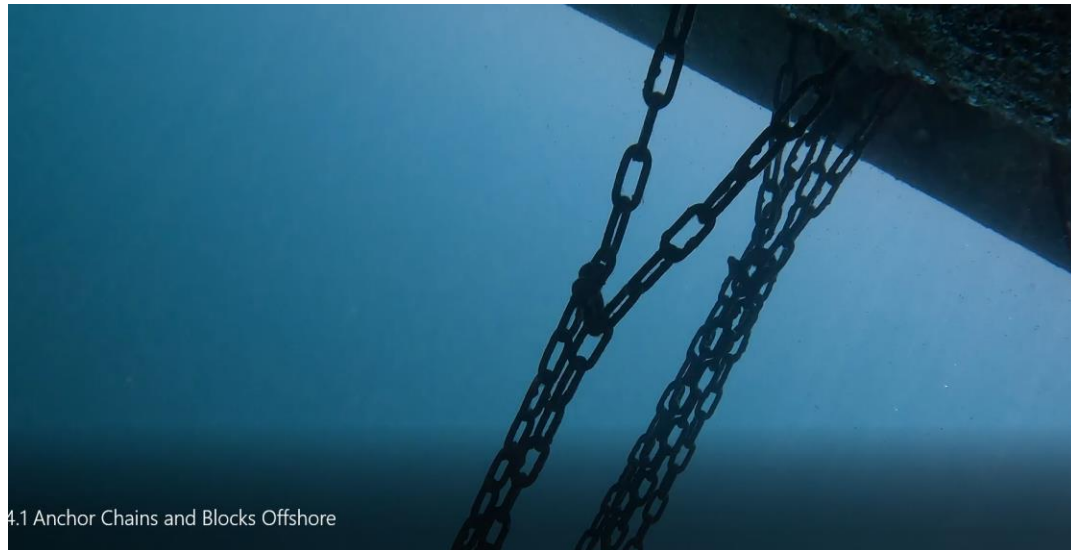
Photo 1.8

Anchor Chain Attachment Under Pontoon - General

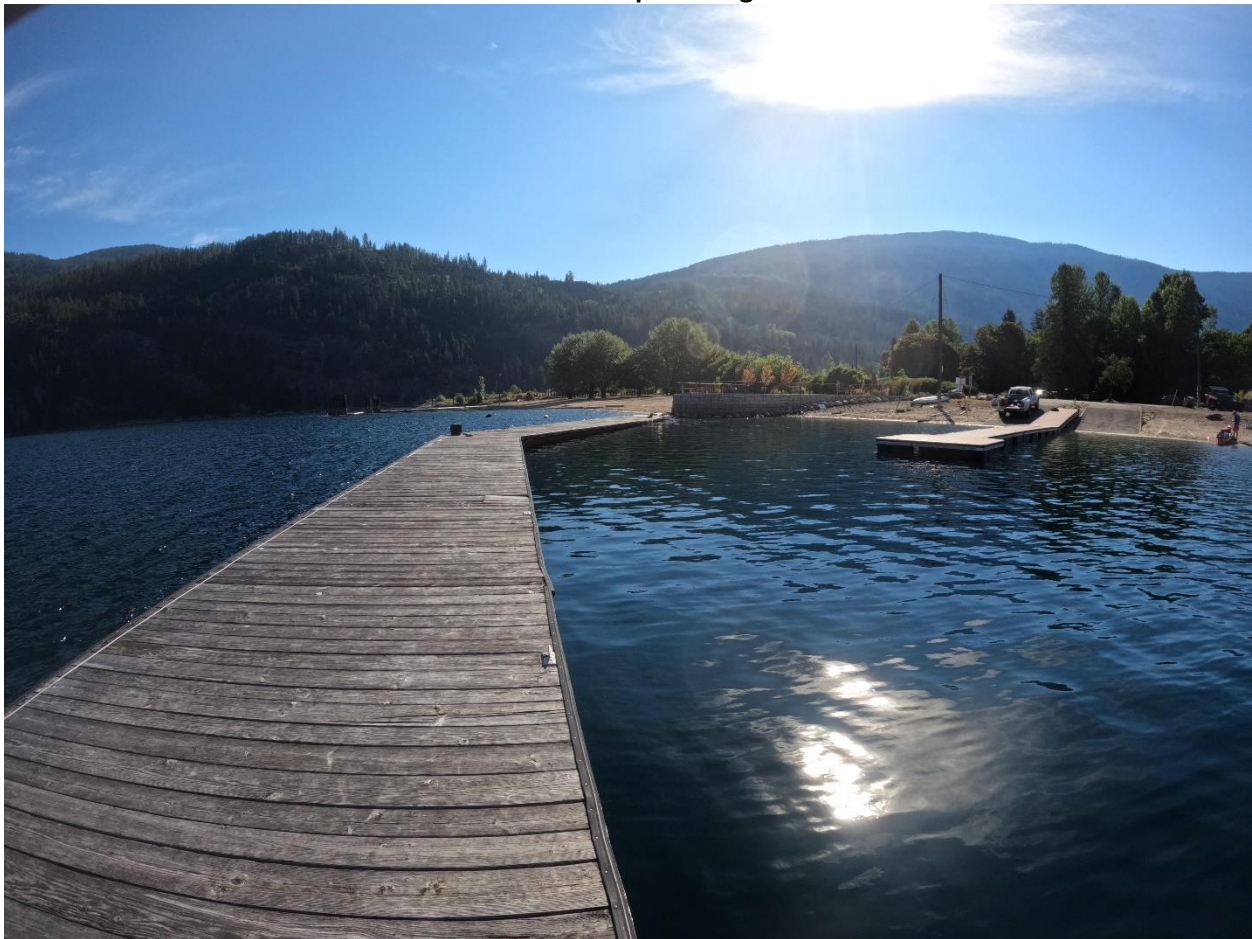
Photo 1.9

- . General top decking is in reasonable condition with some evidence of mild wood rot
- . The deck fascia boards have significant evidence of wood rot due to water exposure
- . Timber cross beams have evidence of wood rot due to water exposure

General Top Decking

It is recommended that the decking and support beam infrastructure consider being replaced over the next two years.

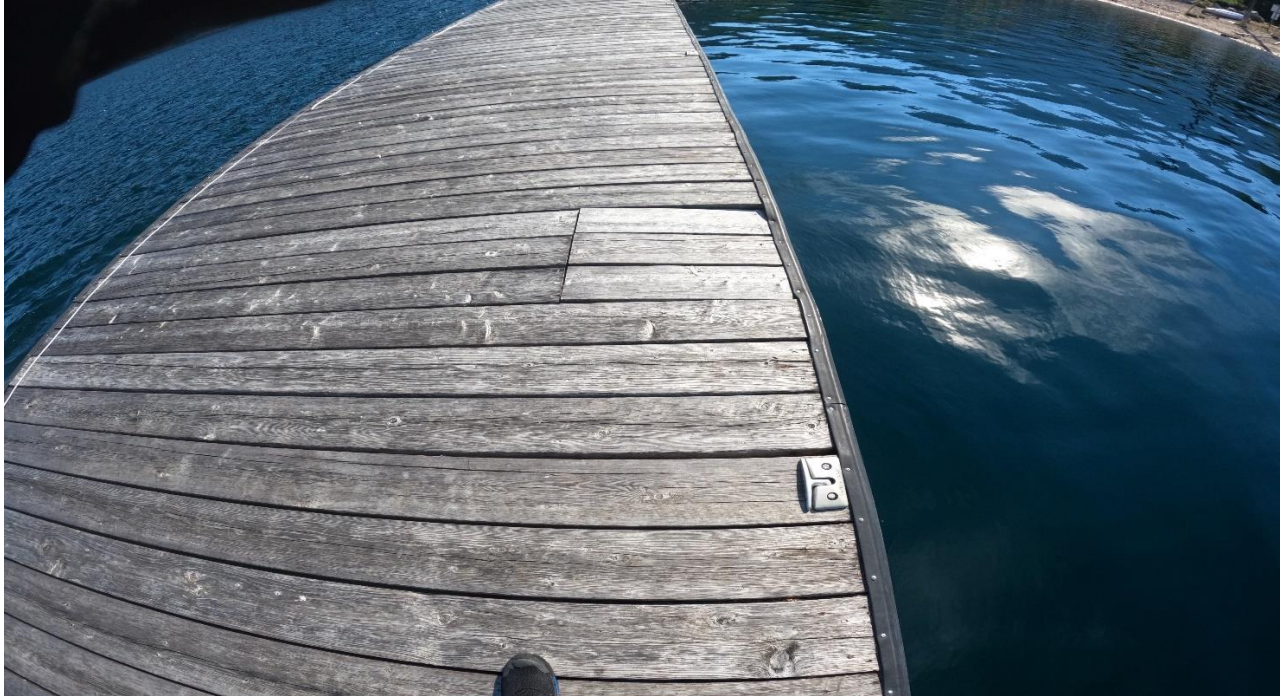
Photo 2.0

Top Decking – General

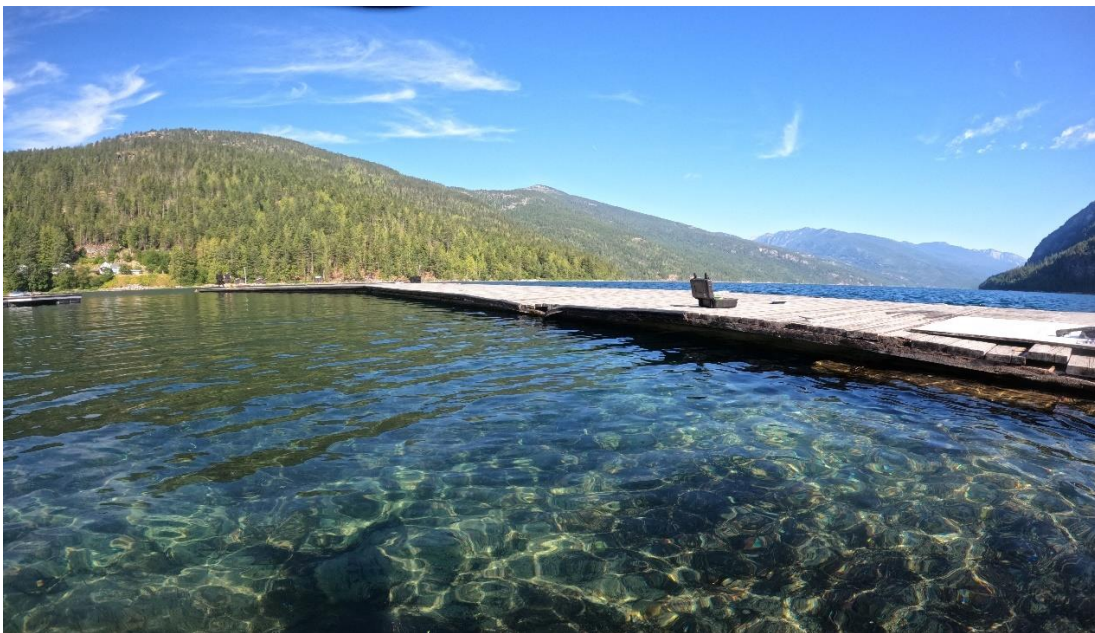
Photo 2.1

Breakwater Fascia Boards – General
