HAZARDOUS AND REGULATED MATERIALS PRE-DEMOLITION ASSESSMENT REPORT

SLOCAN CURLING CLUB BUILDING

903 Hume Street
Slocan, BC

Report Date: August 9, 2022

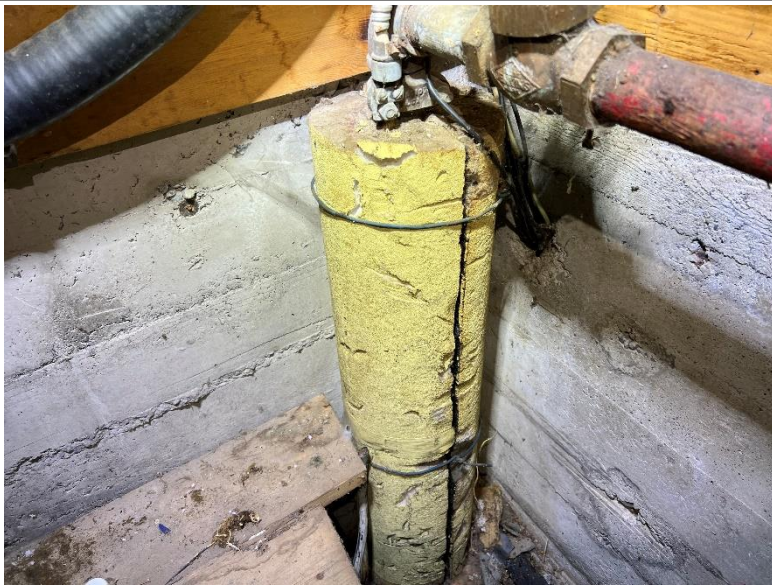
Code Modifier	Material Description	Sample Number / Information	Lab Results
B 1	Foam insulation on chiller piping	Not Sampled	Known Non- Asbestos Application
F 1	Black building paper between floor layers	5808-05	No Asbestos Detected
Ip 1	9x9" Tile pattern beige w	5808-04	No Asbestos Detected
